First evidence of widespread, severe soil erosion underneath centre-pivot irrigation systems

Pedro V.G. Batista ^{a,*}, Victor B. da S. Baptista ^b, Florian Wilken ^a, Kay Seufferheld ^a, John N. Quinton ^c, Peter Fiener ^a

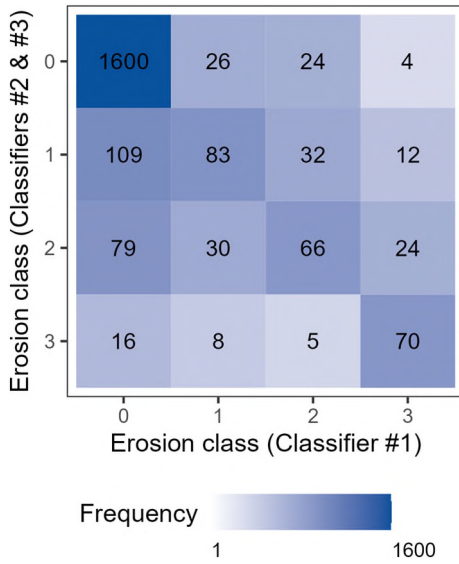
Fig. 6. Confusion matrix for the erosion-feature classes assigned by Classifier #1 and Classifiers #2 and #3 for the centre-pivot-field images. Each column represents the classes assigned by Classifier #1. The rows represent the classes assigned by Classifiers #2 and #3. Numbers in the boxes refer to the frequency of erosion classes assigned by the classifiers.

If we considered only the 2188 centre-pivot-field images with matching image dates, it was clear that the disagreements between classifiers were mostly associated to the assignment of neighbouring categories (Cohen's kappa = 0.53; RMSD = 0.24) (Fig. 6). This pattern was particularly evident for erosion classes 1 and 2, which displayed the lowest classification agreement (74 % and 72 %, respectively). The discrepancies in these classes were expected, as the identification of smaller rills is error prone. Moreover, distinguishing what constitutes a legacy rill, compared to an actively eroding one, is partially subjective. Nevertheless, Classifier #1 assigned a greater proportion of eroding centre-pivot images to Class 3 (29 %) and a lesser proportion to Classes 1 and 2 (38 % and 33 %, respectively), compared to Classifiers #2 and #3 (Class 1 = 44 %, Class 2 = 37 %, Class 3 = 19 %) (Fig. 6).

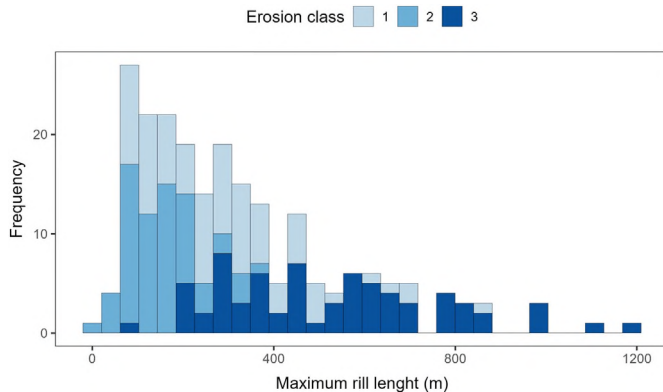
Fig. 9. Stacked histogram of the longest rill lengths per centre-pivot field observed in the GE images for irrigated areas in Cristalina, Brazil.

The median length of the longest rill per centre-pivot image was 260 m (interquartile range = 151–440 m), with a maximum value over 1200 m (Fig. 9). These rill lengths are some of the longest described in the scientific literature and exceed those found in Boardman (2016), Fischer et al. (2018), Prasuhn (2020), and Van Oost et al. (2005). Rills underneath centre pivots in Cristalina appear commensurate to gully networks, such as those developed in olive orchards in Spain (Castillo et al., 2012). In some cases, the centre-pivot images illustrate widespread signs of soil erosion over a large proportion of the field, significantly impacting on crop production (Fig. 10).

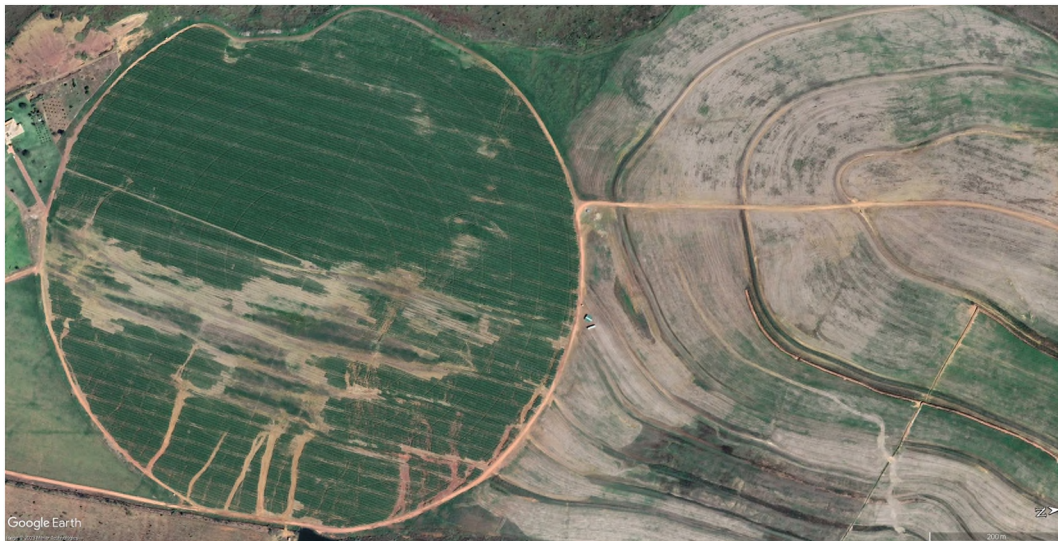
Fig. 10. Severe signs of soil erosion over a large proportion of the centre-pivot field (Pivot ID 11508, diameter = 800 m), compromising crop yields in the affected area (about 30 % of the field) (May 2020). Adjacent rainfed, terraced cropland on the right side of the image does not show similar erosional features. Imagery from Google Earth™.

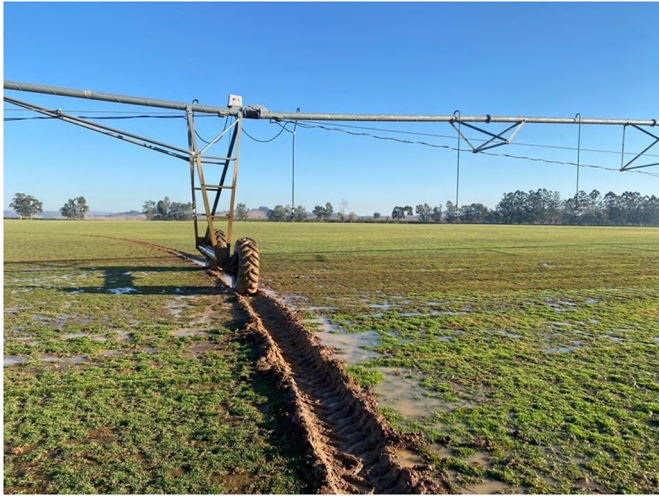
Fig. 12. A centre-pivot wheel creating a compacted track as it moves over wet soil with surface ponding in Macaia, Minas Gerais, Brazil. Photo from Victor B. S. Baptista.
