Influence of corrosion on the mechanical properties of hybrid sandwich structures with CFRP face sheets and aluminum foam core

S. Ilinzeer, P. Rupp*, K.A. Weidenmann

^a *Institute for Applied Materials, Karlsruhe Institute for Technology, Karlsruhe, Germany*

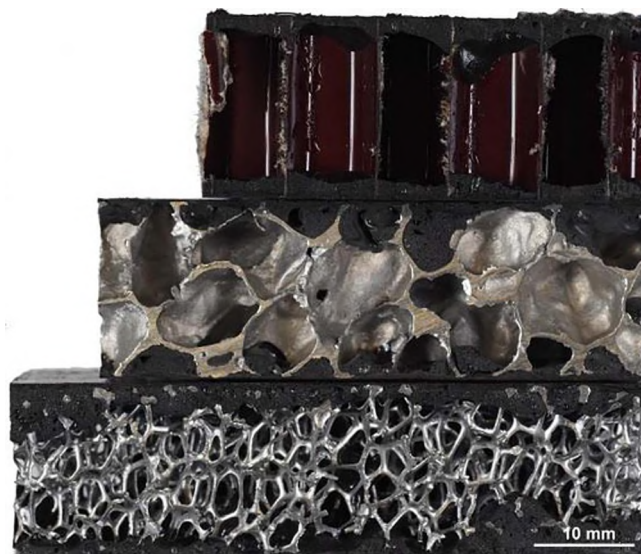
Fig. 1. Sandwich specimens with Nomex honeycomb core (top), closed cell (middle) and open cell aluminum foam core (bottom).

Two different hybrid sandwich panels with varying aluminum foam core materials were provided for the present work (Fig. 1). The first core material was an open cell aluminum foam (AlSi7Mg0.3, 10 ppi, approx. 5% relative density) produced by the company m-pore in Lindenberg, Germany. The second aluminum foam core type used was a closed cell aluminum foam named Alcoras (4 ppi, approx. 8% relative density) which was supplied by AlCarbon, a company set in Bremen, Germany.

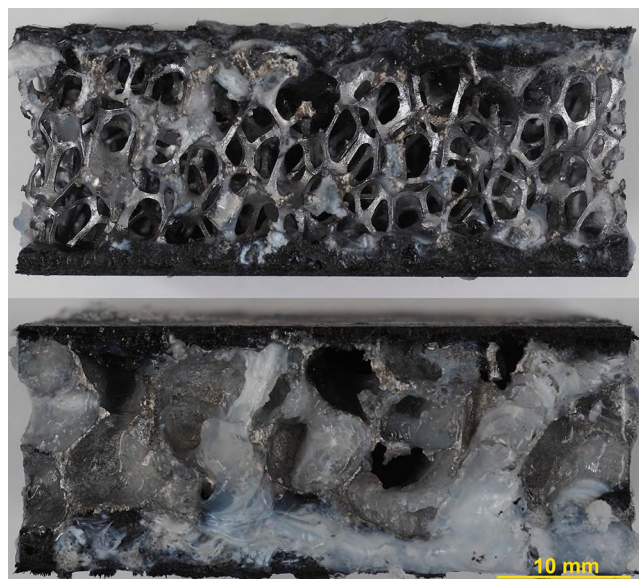
Fig. 4. Sandwich specimens with open (top) and closed cell aluminum core layer (bottom) directly after 240 h of exposure to the corrosive environment.

Following the exposition of the sandwich specimens to the salt spray environment, these specimens underwent a visual inspection before further mechanical testing was performed. Fig. 4 shows that all sandwich types with aluminum foam core exhibited a significant amount of corrosion products inside the respective core material, including the specimens with a blasted core layer.

The corrosion products show a visual similarity to corrosion products detected by [7] in aluminum foam. Especially closed cell foams showed a large amount of corrosion products inside cells close to the foam surface. The amount of corrosion products grew with increasing corrosion duration for both core types. The large quantity of corrosion product suggests that corrosion processes occurred during salt spray testing, however, no corrosion damage of any kind, e.g. pitting corrosion, in either core type could be found. Sandwich specimens with Nomex honeycomb core on the other hand showed no signs of corrosion damage or corrosion products at all, even after 240 h of corrosion time.

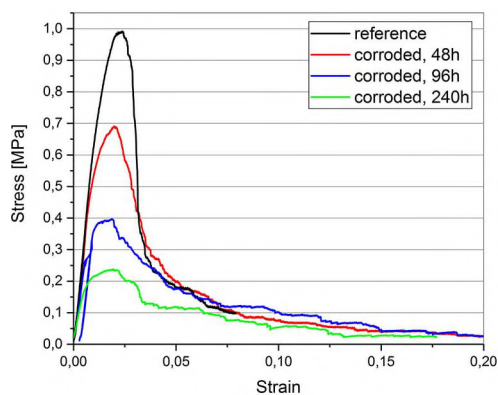
(a) open cell

Fig. 6. Stress-strain curves of open cell (a) and closed cell (b) hybrid sandwich specimens during the flatwise tension test.

The stress-strain-curves of the open cell sandwich specimens resulting from flatwise tension tests are shown in Fig. 6(a). One stress curve for each given corrosion duration is plotted, as is the stress curve of a non-corroded specimen for reference. After only 48 h of exposure to the corrosive environment, specimens already showed a distinct decrease of tensile strength. With each following step of increasing corrosion duration, a further reduction in tensile strength was noticed.

All tested open cell sandwich specimens exhibited failure inside the aluminum foam core layer independent of corrosion duration. The crack was usually initiated at the center core area, followed by uneven crack propagation through the core layer. The mean tensile strengths of the open cell sandwich specimens as a function of the corrosion duration are given in Fig. 7(a). As this graph shows, the reference specimens reached the highest average tensile strength of 0.94 MPa. Sandwich specimens, which were corroded for 48 h, exhibited a decrease in mean tensile strength to 75% (0.70 MPa) of the original tensile strength. After 96 h and 240 h of corrosion duration the average tensile strength was determined to be 41 % (0.39 MPa) respectively 24% (0.23 MPa) of the tensile strength previous to the corrosion process. Similar results can be found for the average stiffness of the open cell sandwich specimens, which was normalized to the mean stiffness of the reference specimens,

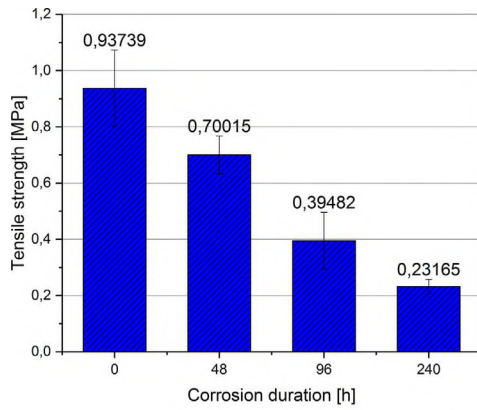
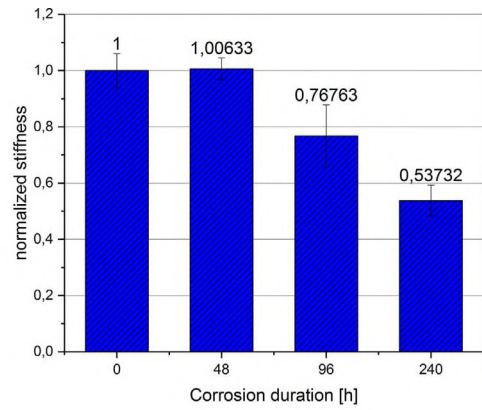
(a) open cell mean tensile strength

(b) open cell normalized mean stiffness

Fig. 7. Mean material properties of blasted, open and closed cell sandwich specimens in dependence of the corrosion duration.

as can be seen in Fig. 7(b). After 48 h of corrosive exposure, no significant decrease in mean stiffness could be seen in comparison to the reference specimens. Further increases in corrosion duration however lead to a decline in mean stiffness to 77% after 96 h respectively to 54% after 240 h.

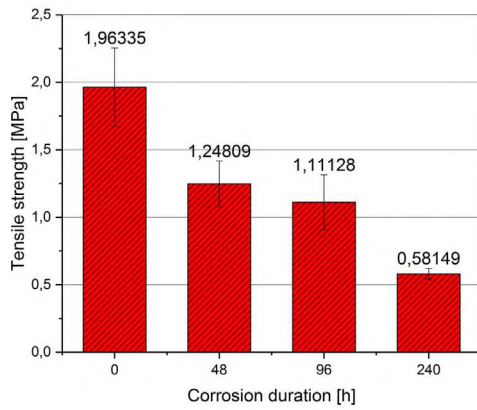
(c) closed cell mean tensile strength

(d) closed cell normalized mean stiffness

A comparison of mean tensile strengths of corroded closed cell sandwich specimens as function of the corrosion time is shown in Fig. 7(c). Reference specimens reached the highest average tensile strength (1.96 MPa), whereas corrosion durations of 48 h respectively 96 h resulted in a reduction of mean tensile strength to 64% (1.25 MPa) respectively 57% (1.11 MPa) compared to the reference. After 240 h of exposure to the corrosive environment, the average tensile strength was determined to be 30% (0.58 MPa). Corroded specimens showed a mean stiffness which was reduced to approx. 90% after 48 h and 96 h respectively 79% after 240 h compared to the reference specimens (Fig. 7(d)).

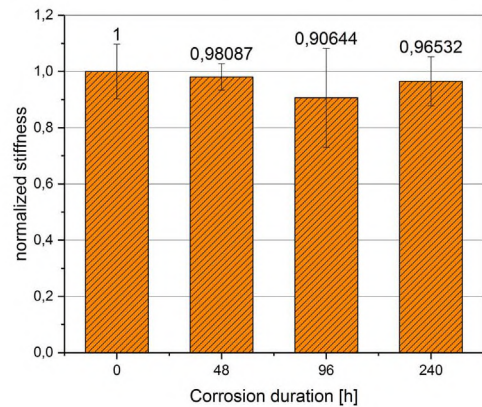
(e) blasted mean tensile strength

(f) blasted normalized mean stiffness

As previously described, the sandwich specimens with a sandblasted closed cell foam core also showed large amounts of corrosion product inside their core layers after exposure to the corrosive environment. Therefore, a similar degradation of the mechanical properties of the sandwich specimens was to be expected with increasing corrosion duration. However, as Fig. 7(e) shows for the mean tensile strength of blasted core specimens, this reduction was neither as pronounced nor as consistent as with the two previously discussed specimen variants. The reference specimens reached the highest mean tensile strength (0.77 MPa), while the corroded specimens reached 0.70 MPa and 0.44 MPa after 48 and 96 h, respectively. The last set of specimens,

which was corroded for a total of 240 h, displayed a mean tensile strength of 0.56 MPa, resulting in an overall higher value than the two previous duration levels.

In comparison to the other closed cell core layer specimens, blasted core specimens showed a significantly lower maximum tensile strength, more on par with the open cell variants. Also, a relatively large scatter of measured tensile strengths was observed during the entire test series

with this type of specimens. Due to this scatter of measurements no significant decrease of tensile strength with increasing corrosion duration could be determined for blasted core specimen variants. In Fig. 7(f), the normalized mean stiffness of blasted specimens is displayed. It can be seen that there was no significant decrease in stiffness with increasing corrosive exposure. As with the strength measurements, the large data scatter obscured any corresponding observations. Crack

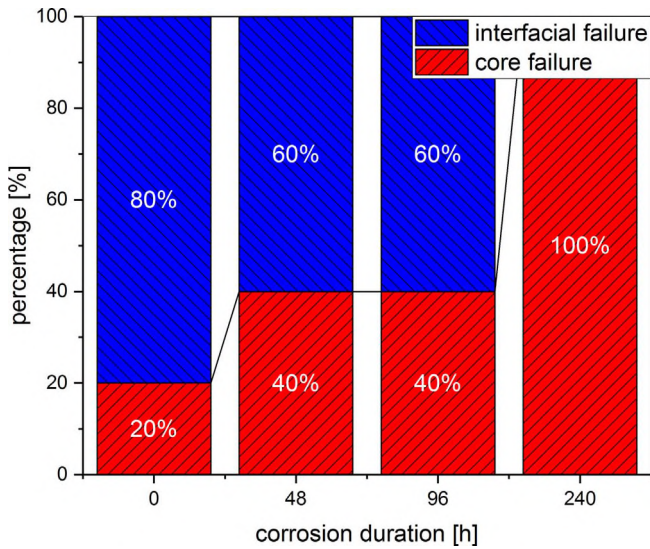
Fig. 8. Comparison of failure mode in dependence of corrosion duration for closed cell sandwich specimens.

failure mode of closed cell sandwich specimens towards core failure (Fig. 8) also indicates erosion of the aluminum foam core. No similar shift in failure mode could be determined for the open cell or blasted core sandwich specimens. It seems like the core layer was the weakest part of the open cell sandwich specimens even in its reference state, with the corrosive process only further weakening it.

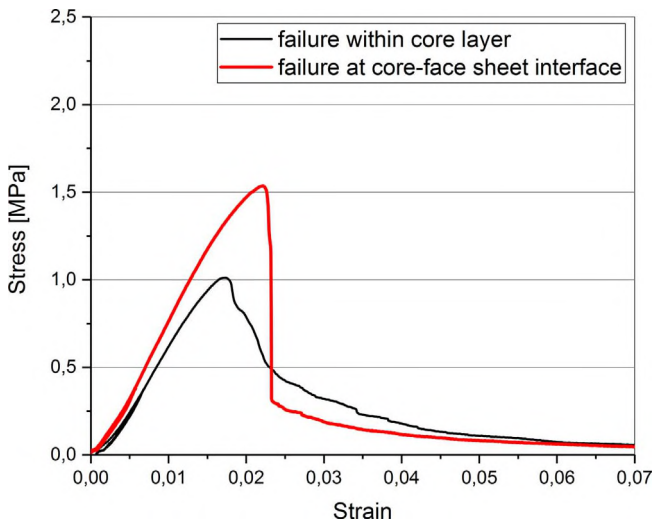
Fig. 9. Stress-strain curves of closed cell sandwich specimens with differing failure mode after 48 h of exposure to the corrosive environment.

Fig. 6(b) shows the stress-strain-curves of the sandwich specimens with a closed cell aluminum foam core structure for the respective corrosion durations. As already observed for the sandwich specimens with open cell core structure, the highest tensile strength was once again obtained with the reference specimens. Reduced tensile strengths were achieved with increasing corrosion duration. Also, a change in failure mode was detected with increasing corrosion duration (Fig. 8). While all but one of the five reference specimens failed at the interface between core and face sheet, a shift towards core failure was noticed with increasing corrosion duration. Specimens, which were exposed to the corrosive environment for 48 h respectively 96 h, exhibited core failure in two out of five cases, whereas 240 h of salt spray testing resulted in all four of the specimens failing inside the core layer during flatwise tension testing. Failure at the interface between core and face sheet always resulted in a sudden drop in the respective stress curve whereas core failure lead to a rather even decrease of measured stress during further crack propagation (Fig. 9). In addition, it was noted that specimens failing at the interface always reached higher maximum stress levels than specimens of equal corrosion duration failing inside the core layer.

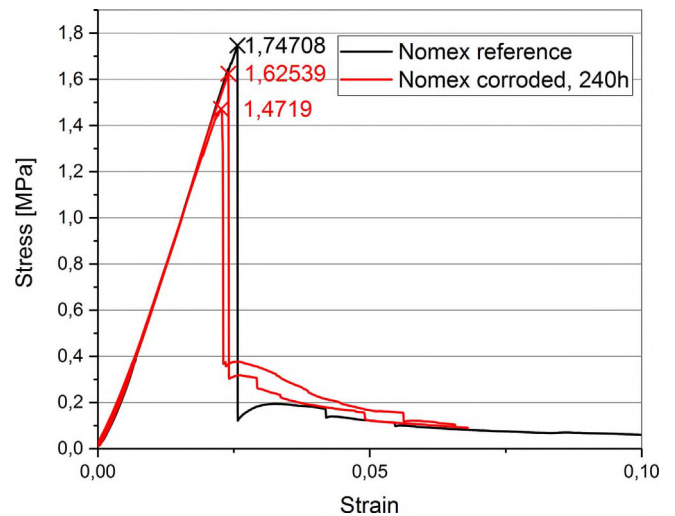
Fig. 10. Stress-strain curves of sandwich specimens with Nomex honeycomb core layer after 240 h of corrosion in comparison to a reference specimen.

The stress-strain-curves of the tested sandwich specimens with Nomex-honeycomb core layer are shown in Fig. 10. Both the corroded and the reference specimens exhibited linear-elastic material behavior at the beginning of the testing procedure with a sudden drop in measured stress after reaching the respective tensile strength, accompanied by material failure inside the honeycomb core layer. The reference specimen reached the highest tensile strength (1.75 MPa) whereas the corroded specimens reached 1.63 MPa and 1.47 MPa, respectively. The absence of corrosion products within this type of specimens indicates that the decrease of tensile strength likely results from material scatter rather than salt spray testing. It is possible, that a different amount of structural elements was present within each Nomex specimen after cutting the specimens from the sandwich plate. Also, water absorption inside the face sheet material may have had a negative influence on the mechanical properties as well, as observed by [12]. The absence of any significant deviation of measured tensile strength of corroded honeycomb specimens in comparison to their reference counterparts therefore indicates that it was indeed galvanic corrosion that affected the mechanical properties of the aluminum foam sandwich specimens.
