## Dual-energy CT for the evaluation of silicone breast implants

# Dual-energy CT for the evaluation of silicone breast implants

## Abstract

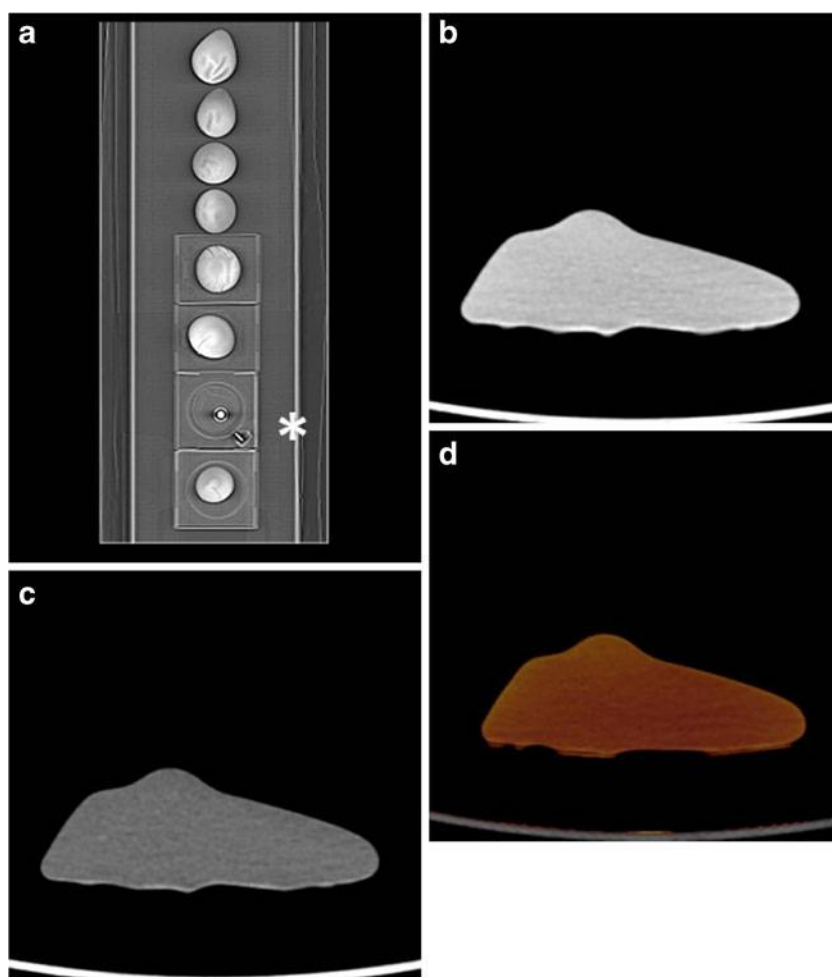
**Fig. 1** Topogram showing seven different silicone breast implant specimens and one spacer [\*] (a). CT images of a silicone implant obtained simultaneously at 100 (b) and Sn 140 kVp (c). Colour coding of the photoelectric effect shows homogeneous signal in the implant (d)

The implants showed a strong dual-energy signal of both the silicone inside the implant and the elastomer shell with a contrast-to-noise ratio of  $8 \pm 1$  (Fig. 1). There were small differences in the individual density values of the specimen implants (ranges 115–131 HU at 100 kVp vs. 7–21 HU at Sn140kVp). There were also slight differences in density in different areas of the same implant, depending on the configuration and resulting differences in beam hardening and cupping artefacts. Thus, the differences in density between the prostheses of different suppliers were not significant and would not allow a differentiation.

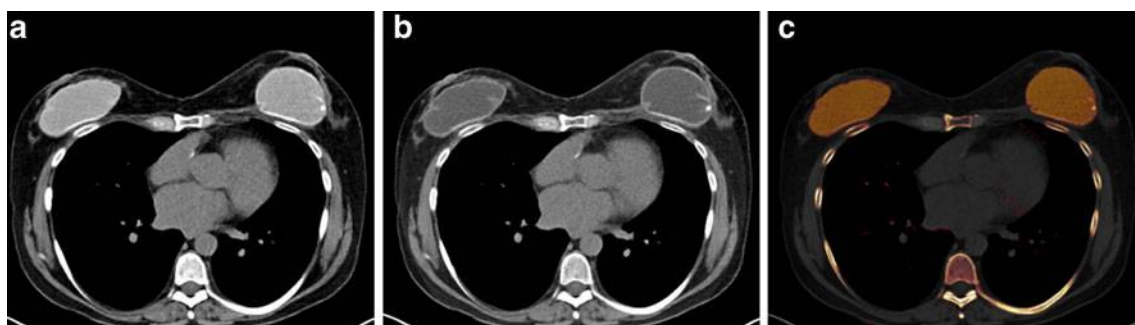
**Fig. 2** A 48-year-old patient (patient A) examined for implant evaluation; CT images obtained simultaneously at 100 (a) and Sn 140 kVp (b) and colour-coded silicone (c). There is strong signal from the silicone and no evidence of rupture

In the patient examinations, the density values in both patients were equivalent (104 HU at 100 kVp/6 HU at Sn140kVp). Colour coding of the silicone highlighted the implants with strong contrast and very weak noise in surrounding tissue. In patient A, the silicone signal was confined to the envelope of the implants (Fig. 2). In patient B with the PIP prostheses, an extracapsular rupture was identified in the posterior lower inner aspect of the left implant (Fig. 3). The shell also showed multiple folds and layers crossing the silicone inside, suggesting a rupture and collapse of the shell.

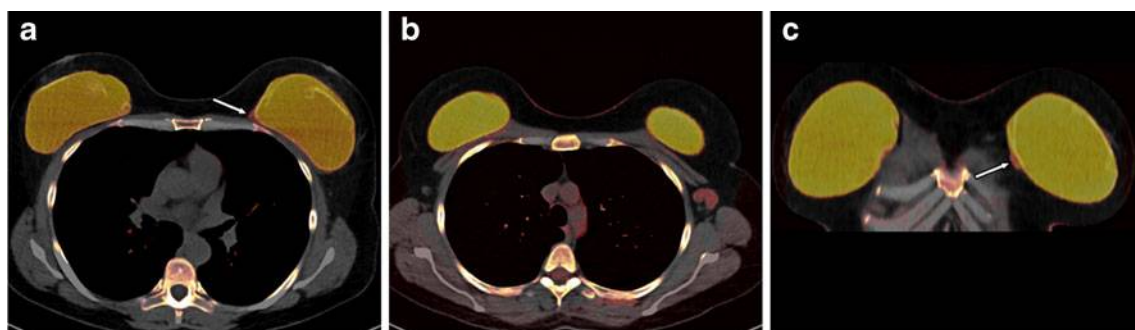
**Fig. 3** A 51-year-old female patient (patient B) examined for the evaluation of PIP implants before surgical removal; CT images in axial (a, b) and coronal (c) orientation with colour-coded silicone signal.

Note the silicone extending outside the inferior medial shell of the left implant (arrows in a and c) and the silicone signal in the enlarged axillary lymph node (b)

There were enlarged axillary lymph nodes on the same side, which also showed a strong silicone signal.

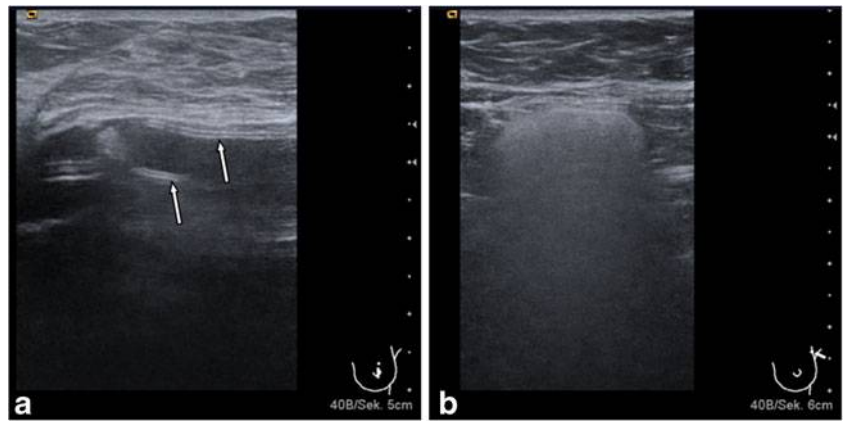
**Fig. 4** Ultrasound images of patient B showing a “stepladder” sign of the implant (arrows in **a**) and increased echogenicity of the corresponding enlarged axillary lymph node (**b**)

Ultrasound images had been acquired at initial presentation and were available for correlation in both patients. There was no sign of rupture in patient A, whose implants appeared intact on CT. In patient B with the suspected rupture, ultrasound showed a “stepladder” sign of the implant and a “snowstorm” sign in the axillary lymph node on the same side (Fig. 4). With the ultrasound and CT findings suggesting implant rupture, patient B then agreed to MRI with sedation for surgical planning. MRI also indicated rupture of the left implant with “linguine” and “salad oil” signs in the implant and strong signal in the axillary lymph node in silicone-specific sequences (Fig. 5).

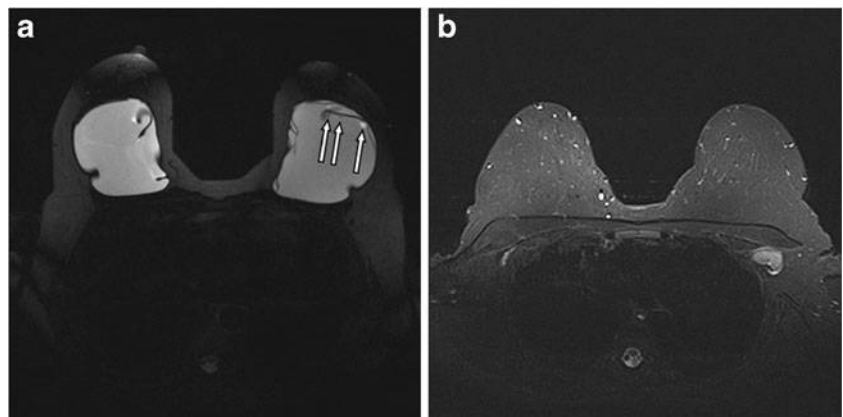
**Fig. 5** MRI of patient B showing a “salad oil” sign in the left implant on T2-weighted sequences (arrows in **a**) and increased signal of the enlarged left axillary lymph node on silicone-specific sequences (**b**)

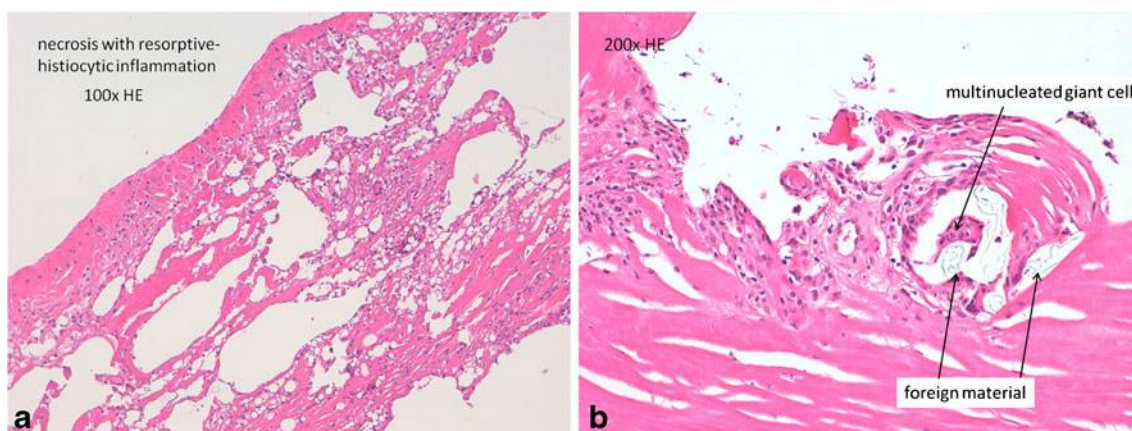
**Fig. 6** Histology of patient B showing necrosis with resorptive histiocytic inflammation (a) and formation of granulomas with multinucleated giant cells around foreign material (b)

In patient B, histology confirmed silicone outside the implant with the formation of granulomas in the tissue medial and inferior of the implant (Fig. 6).
