## **Pannus formation after transcatheter aortic valve implantation resulting in prosthetic valve dysfunction: a case report**

# Pannus formation after transcatheter aortic valve implantation resulting in prosthetic valve dysfunction: a case report

Subaortic pannus • Bioprosthetic valve dysfunction • Transcatheter aortic valve implantation • Sapien 3 aortic valve • Case report

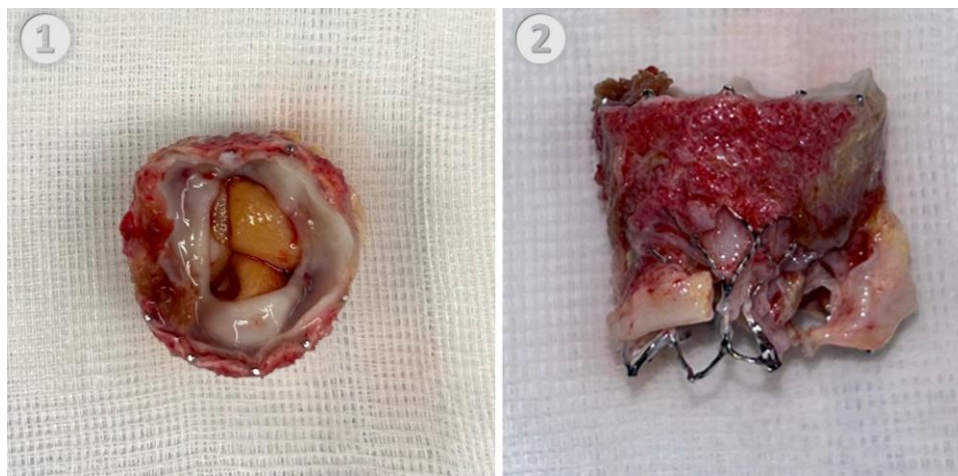
observed, obliterating the valve opening area, particularly under the right and non-coronary leaflets (Figure 2). The prosthetic valve was explanted while preserving the integrity of the aortic wall and aortic valve annulus. Mitral valve repair was achieved using a 30-mm IMR annuloplasty ring (Edwards Lifesciences Corporation, Irvine, CA, USA). A sutureless Perceval bioprosthesis Size L (CorCym, London, UK) was implanted in the aortic position, and tricuspid valve repair was achieved using a 32-mm Cosgrove ring (Edwards Lifesciences Corporation, Irvine, CA, USA). Postoperative echocardiography showed good results, with a transprosthetic aortic valve peak velocity of 3.0 m/s, a mean PG of 19 mmHg, and no paravalvular leakage.

**Figure 2** (1) Extracted bioprosthesis aortic valve (Edwards SAPIEN 3), with pannus formation on the ventricular inflow site. (2) Side view of the extracted bioprosthesis valve.
