Scan quality optimization for measuring Fiber-Metal-Laminates with X-Ray computed tomography

Florian Thum, Mario Zott, Markus G. R. Sause

Thum, Florian, Mario Zott, and Markus G. R. Sause. 2020. "Scan quality optimization for measuring Fiber-Metal-Laminates with X-Ray computed tomography." In *10th Conference on Industrial Computed Tomography (iCT2020), Wels, Austria, 4-7 February 2020*. Wels: FH OÖ Forschungs & Entwicklungs GmbH.

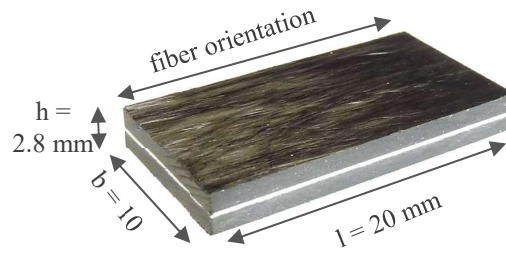
CFRP $[0^\circ]_5$	1.25 mm
Aluminium	0.3 mm
CFRP $[0^\circ]_5$	1.25 mm

Figure 1: Stacking sequence of the FMLs (left) and specimen dimensions for SBS testing

The specimens examined in this measurement series consist of an Al1050 aluminum core (0.3 mm thickness) and two outer layers of carbon fiber reinforced PA6 (containing 5 laminate layers each) in $[0^\circ]$ fiber orientation as shown in Figure 1. The fiber orientation was chosen according to the SBS (DIN EN 2563) testing standard. The beam hardening effect was compared between six different filter combinations as well as to a scan without any filters and a scan using synchrotron radiation. One specimen was scanned with the established parameters after short-beam shear testing to demonstrate the possibility of assessing the interlayer and possible failure modes.

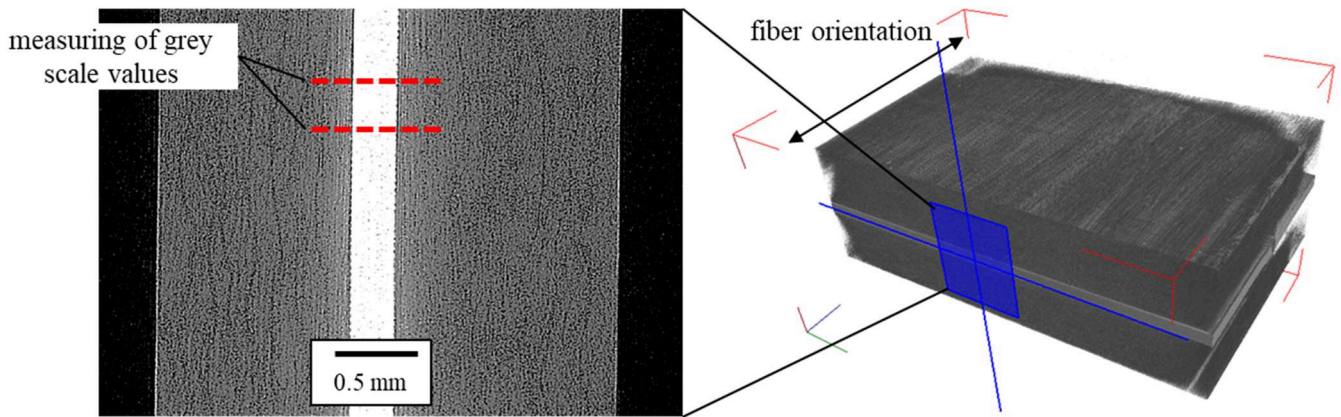
Figure 2: Cross section of specimen showing contrast between aluminum and CFRP (left) and position of selected region of interest (ROI) in the volume rendering of the specimen

As a typical effect of beam hardening, the contrast at the edge of the aluminum sheet is significantly different from the bulk region. Therefore, the imaging quality for the different settings is compared by plotting the gray value profiles along the dashed lines seen in Figure 2. As quality indicator, the slope of the edges at the aluminum-CFRP transition can be evaluated by a linear regression as shown in Figure 3. Each volume scan was investigated within the same cross-section at the middle of the specimen.

In each filter setting, a representative cross section of the inner part of the volume (as seen in Figure 2) was used to extract the grey value profiles at the interface of the FML. Three profiles in each volume were used to generate the slope values shown on the right side of Figure 3. Visually, a higher slope corresponds to a noticeable improvement of the interface sharpness. This is highly desired to reveal details of defects occurring in this interface region. The absolute grey value difference corresponds to image contrast.

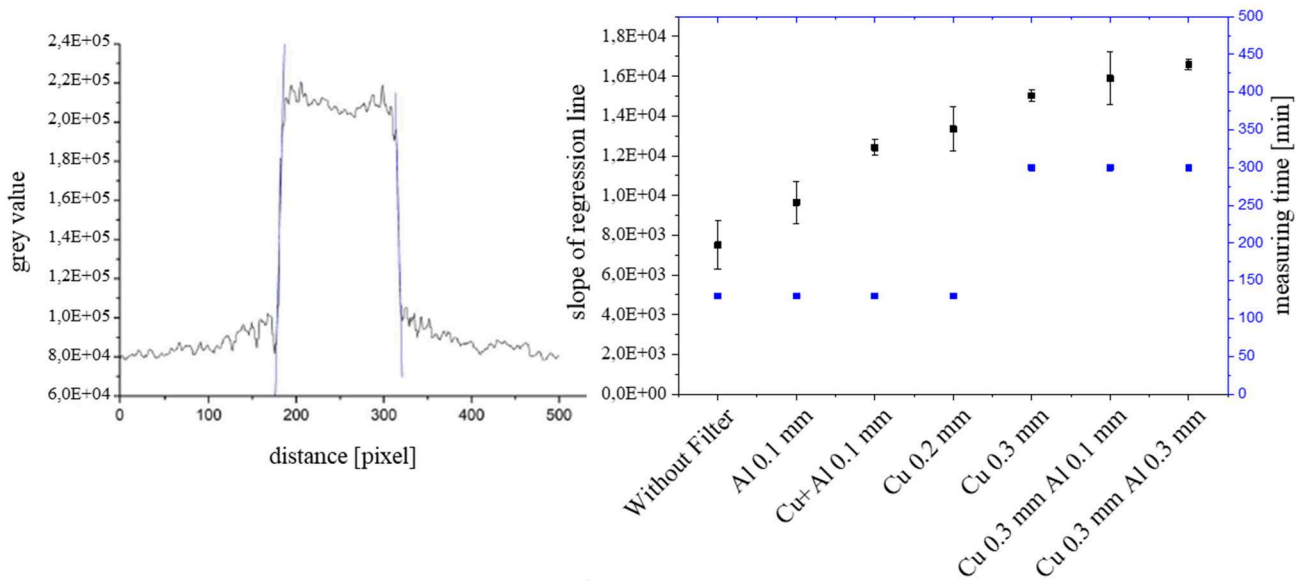
Figure 3: Profile plot of cross section and regression line (blue) at the edges between aluminum and FRP (left), comparison of the influence of different filter combinations (right)

Overall, the evaluation displays a clear trend to improved interface imaging (edge sharpness) with thicker filters. The slope of the regression line of the synchrotron measurement is 1.08×10^9 despite the smaller voxel size, which clearly shows the quality of a wider radiation spectrum. For scaling reasons, it was left out of the diagram in Figure 3. The other samples are listed with ascending filter thickness and measuring time.

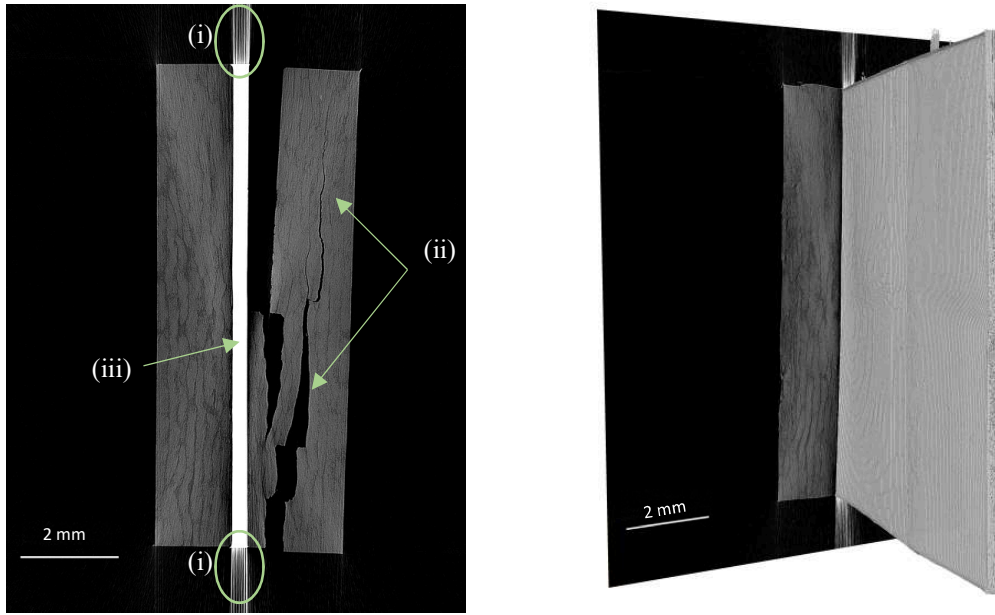
Figure 4: Specimen No. 9 after SBS testing. Beam hardening is clearly visible at the long edges (i) of the aluminium foil, however there is clear edge at the interface to the CFRP layers. Matrix failure (ii) and delamination at the interface (iii) can be identified.

Fehler! Verweisquelle konnte nicht gefunden werden. shows a 2D cross-section of a SBS-tested sample as well as a combination of an ortho slice and the segmented aluminum core. Although there are noticeable beam-hardening artefacts at the short edges of the aluminum layer, the direct interface to the CFRP layer has a sharp edge. However, the scan shows that depending on the specimen's geometry, beam-hardening is influencing the image quality significantly. The aluminum layer can still be segmented without the artifacts at the short edges using a manual seeding based segmentation process.

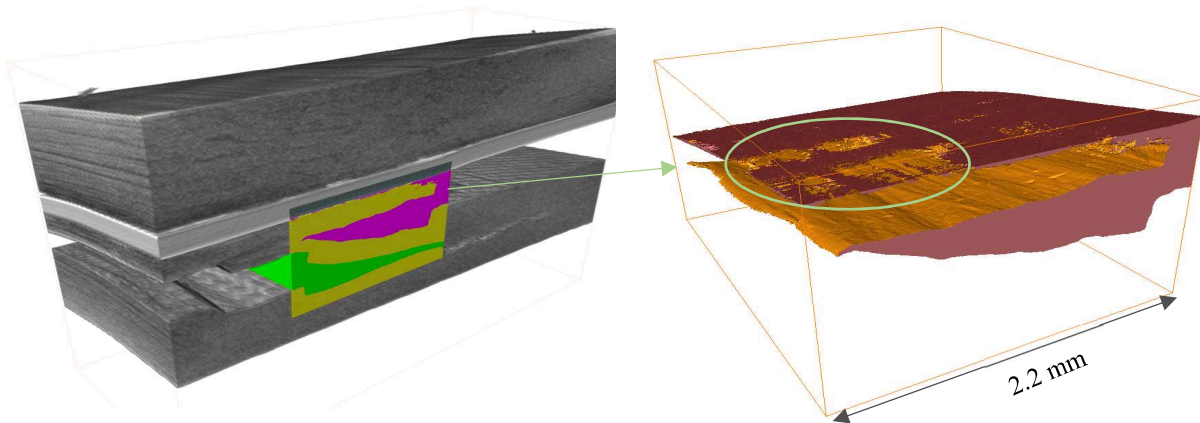
Figure 5: Region of Interest after SBS testing, segmentation of damage close to the aluminum surface. The segmented defect on the right shows parts of the delamination as well as cohesive and adhesive failure.

The quality of the scan using a 0.3 mm Copper filter allows for segmentation close to the aluminum layer and thus for dimensional and geometric measurements of defects within this area. The segmented region is shown in **Fehler! Verweisquelle konnte nicht gefunden werden..** Segmented defects can be quantified in terms of volume and surface. As a result, the cohesive and adhesive failure share at the aluminum interface can be evaluated with this image quality.
