Open Guided Waves: online platform for ultrasonic guided wave measurements

Open Guided Waves – Online Platform

for Ultrasonic Guided Wave

Measurements

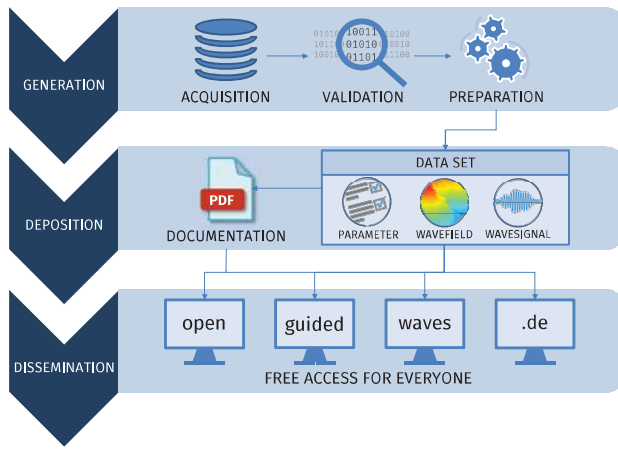
Figure 1. Workflow illustrating data generation, deposition and dissemination.

The underlying idea of the proposed OGW platform is shown in Figure 1 and illustrates the whole process from data acquisition to its distribution. A first test structure, described in *Section 2*, is given by CFRP plates with clearly defined geometry and embedded piezoelectric transducers. To characterize the baseline state, ultrasound and X-ray testing were performed. Material properties in form of the stiffness tensor and sample density were measured, validated and compared with theoretical predictions. A discussion of the reversible damage model used in this work is presented in *Section 3*. Next, *Section 4* describes acoustic

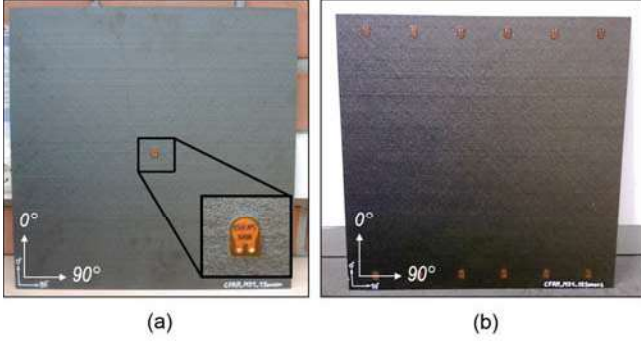
Figure 2. (a) 'Wave field plate' with single transducer in the middle of the structure (b) 'SHM plate' equipped with 12 transducers. One row with six equally spaced transducers is arranged on top and one row at the bottom of the plate. In both plates the horizontal direction denotes a fibre orientation of 90° and the vertical direction represents a fibre orientation of 0°.

A first specimen, called 'wave field plate', with a single piezoelectric transducer in the center was used for acoustic wave field measurements. A second specimen, called 'SHM plate', was equipped with 12 piezoelectric transducers for the acquisition of guided wave data in pitch-catch configuration. Both specimens are shown in Figure 2. Two additional laminates are divided in coupons and undergo mechanical testing to determine the material properties, and to validate the stiffness tensor.

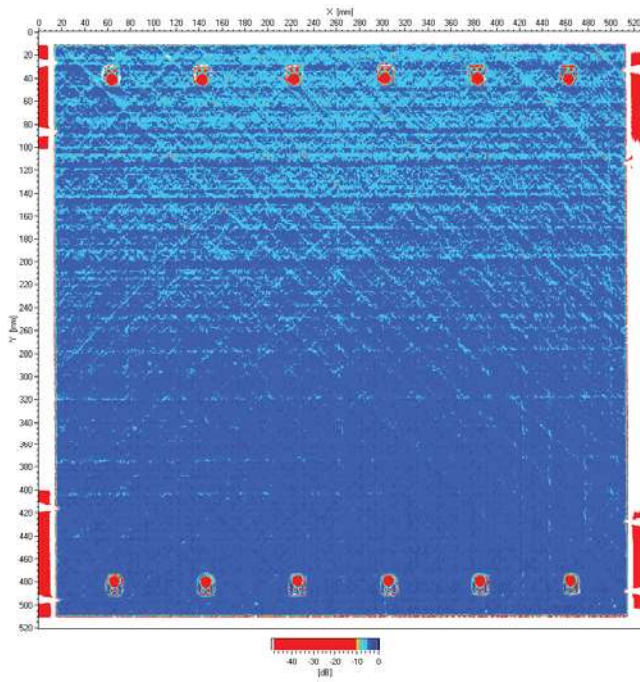
Figure 3. Backwall echo of ultrasonic NDT of the ‘SHM plate’ with 12 cobonded piezoelectric transducers.

Figure 3 depicts the amplitude of the back wall echo in decibels for the 'SHM plate'. The specimen has been evaluated for damage following the 6 dB method described

in (Schnars and Henrich 2006; Brandt and Maaß 2016). In that technique, a composite laminate is considered damage-free if the back wall echo does not drop 6 dB or more in comparison to a defect-free area within the same material, thickness and stacking sequence. The amplitude of the back wall echo in Figure 3 remains between -4 dB and -10 dB, indicating the pristine state of the specimen.

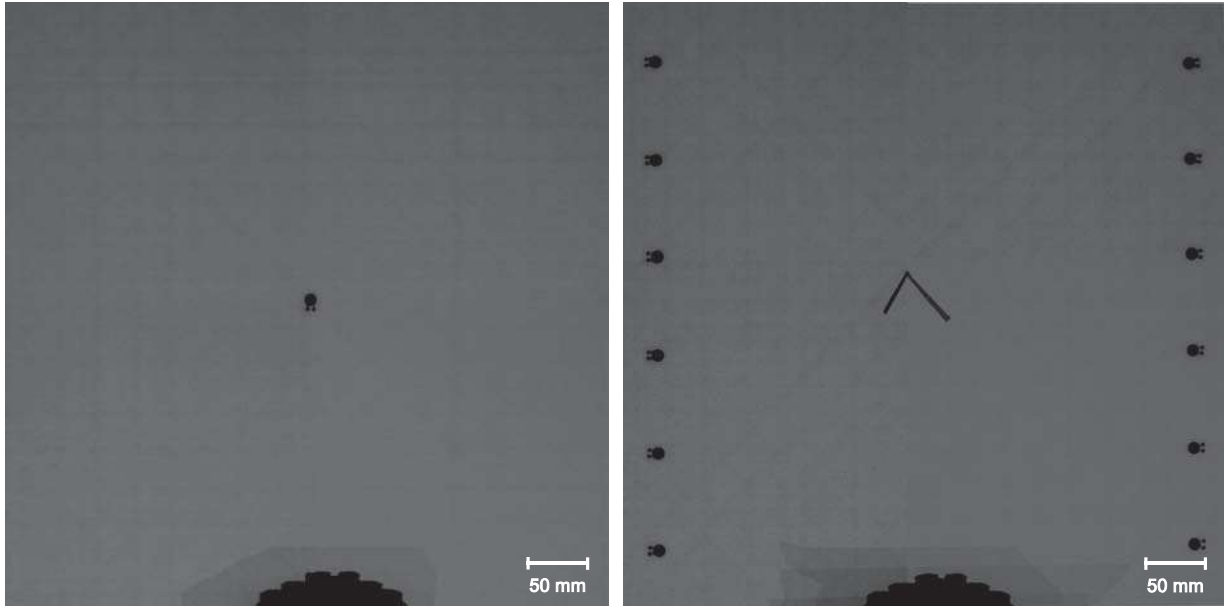
Figure 4. X-ray images of the ‘wave field plate’ (left) and the ‘SHM plate’ (right). The black region at the bottom of both images corresponds to the sample holder used to fix the samples during X-ray measurements. The ‘SHM plate’ shows an upward arrow of copper tape in the center of the plate that was bonded to the specimen to provide correct orientation.

Figure 4 shows the X-ray images for the ‘wave field plate’ and the ‘SHM plate’. Both images show a black region at the bottom corresponding to the sample holder to fix the sample during radiographic measurements. A soft masking tape protects the bottom edge of the plate, which can be seen as a dark shade around the holding device. The piezoelectric transducers can be clearly identified by their black shape. To provide orientation for the ‘SHM plate’, an upward arrow of copper tape was bonded onto the surface and, hence, can be recognized in the center of the corresponding image. Additionally, in both images lines in the direction angles 0° , 90° , and $\pm 45^\circ$ occur, indicating the directions of the laminate plies. Note that there are no further grayscales, which differ from the homogeneous gray that is generated by the unvarying absorption of the material. Commonly, this

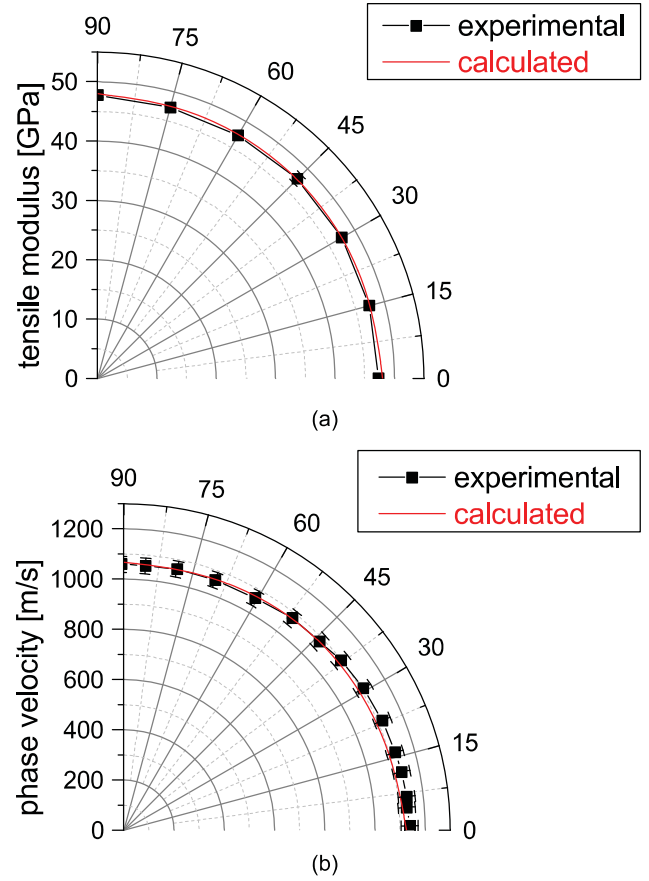
Figure 5. (a) Comparison of stiffness values predict by classical laminate theory and measurement values at 15° angle increments for static tests and (b) comparison of phase velocity obtained by finite element modeling at 50 kHz and obtained by full-field laser vibrometer measurements.

Validity of the stiffness tensor was evaluated by tensile tests following DIN EN ISO 527-4 using off-axis angle measurements at incremental angles of 15° for a quasi-isotropic plate. Within the margin of error, the calculated values coincide with the measurement results, cf. Figure 5(a). For the test frequency of 50 kHz the phase velocity was extracted from full-field laser vibrometer measurements (see Section 4). The result is compared to phase velocities calculated by finite element modeling following the approach in Sause (2016a) and shown in Figure 5(b). Within the margin of error, these calculations agree reasonably well with the experimental results. The obtained stiffness tensor may thus be assumed valid for the test conditions of the ‘wave field plate’ in Section 4 and the ‘SHM plate’ in Section 5.

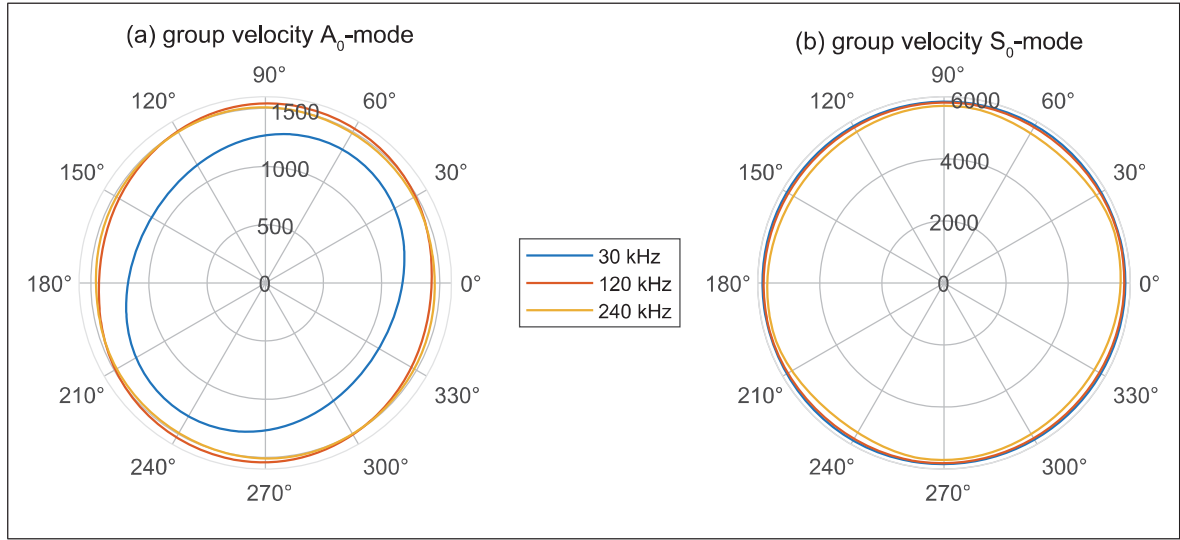
Figure 6. Polar representation of the group velocity in [m/s] for (a) the A_0 -mode and (b) the S_0 -mode. The frequencies shown here reflect the minimum, intermediate and maximum frequencies during the experiments of the undamaged ‘wave field plate’ (see Table 5).

Additionally, the theoretical group velocities were computed by the well-known global matrix method exploiting third order plate theory (Torres Arredondo et al. 2011). The third order plate theory agrees well with the exact three dimensional theory, especially at lower frequency-thickness products (Torres Arredondo 2013). A polar representation of the group velocity for three representative frequencies is shown in Figure 6. Given by the quasi-isotropic stacking sequence the velocity is almost independent of the direction of wave propagation.

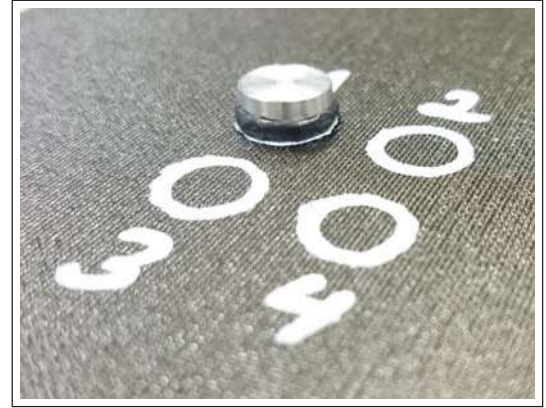
Figure 7. Photo of the reversible damage model in form of an aluminum disc with a diameter of 10 mm coupled to the structure by tacky tape. White circles indicate four closely spaced damage positions, cf. Figure 12.

In this work, we employ a reversible defect model where an aluminum disc is mounted on the surface of the CFRP plate by a tacky tape as introduced in Beard et al. (2005), cf. Figure 7. Although this reference damage is simplified with respect to the geometry of an actual delamination, it's interaction with guided waves behaves similarly in terms of dedicated features like change in time of flight or decrease in amplitude as quantified in Bach et al. (2017).

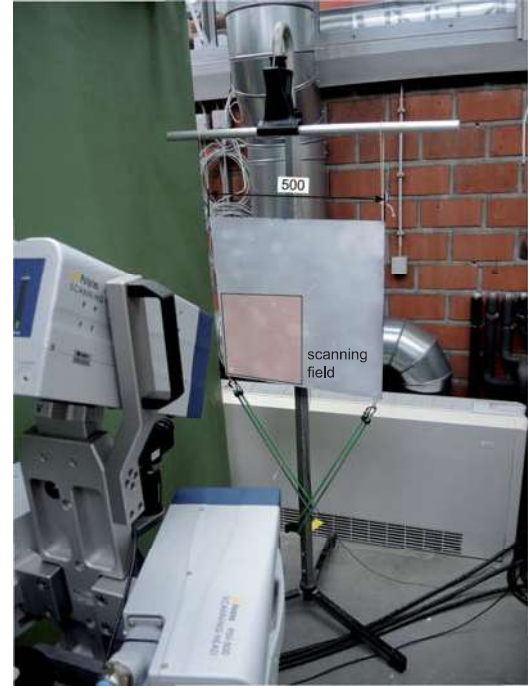
Figure 8. Experimental setup with the scanning laser Doppler vibrometer and the 'wave field plate'.

As shown in Figure 8, full wave field measurements were carried out by a 3D scanning laser Doppler vibrometer PSV-400-3D from Polytec GmbH (Waldbronn, Germany) using a measurement range of ± 200 mm/s. To increase sampling rate to 2.56 MHz the PCI 6110 National Instruments measurement card was used. Measurement subject was the 'wave field plate' introduced before with a central transducer placed exactly in the middle of that structure. The excitation signal is a 5-cycle Hann-filtered sine wave amplified to ± 150 V. To minimize the influence of random measurement noise, every dataset is averaged 100 times. The temperature was kept constant at room temperature, in this case 23°C.

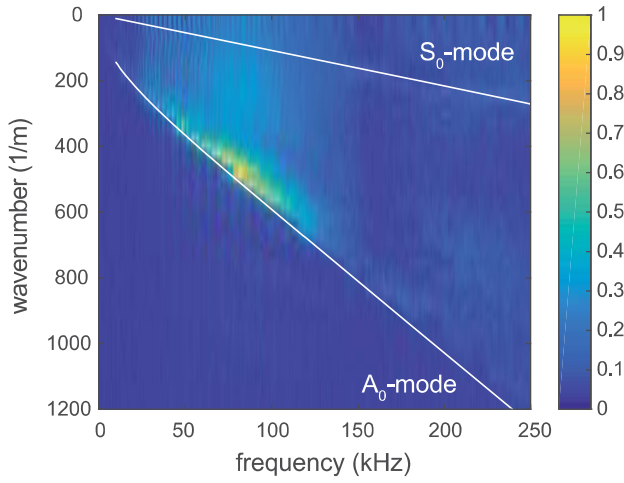
Figure 9. Comparison between theoretically predicted and experimentally measured dispersion properties of the ‘wave field plate’ in 0° direction (see Figure 2). Multiple narrowband measurements were combined to model a broadband pulse. The experimental dispersion graph was normalized to the maximum amplitude of the antisymmetric wave mode. Theoretical dispersion curves were computed with the global matrix method (Torres Arredondo et al. 2011).

Figure 9 depicts the measured wavenumbers of the 'wave field plate' along 0° direction (see Figure 2) as a result of a 2D Fourier transform in relation to theoretically predicted dispersion curves in the multilayered laminate. The theoretical dispersion curves are in good agreement with the experimental dispersion curves. Additionally, mode tuning behaviour can be observed which describes the capability

of piezoelectric transducers to excite and detect Lamb waves (Giurgiutiu 2005). In the present case the maximum of A_0 -mode excitation is in the region of about 80 kHz and decreases to lower and higher frequencies, respectively.

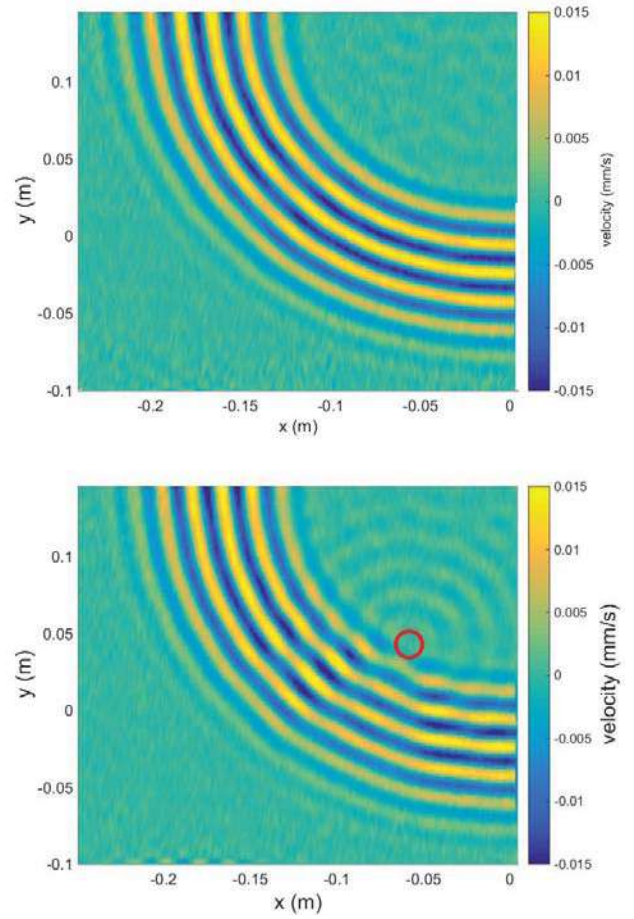
Figure 10. Snapshot of the acoustic wave field excited at 50 kHz after 155.8 μ s. Snapshot (left) for the undamaged structure and (right) for the damaged structure showing antisymmetric wave mode scattering at the defect. The damage position is marked by a red circle.

Additionally, Figure 10 shows snapshots measured at 50 kHz for the intact structure and for the structure with the reference damage placed at $x=-0.059$ m and $y=0.045$ m. Antisymmetric wave mode scattering can be clearly observed.

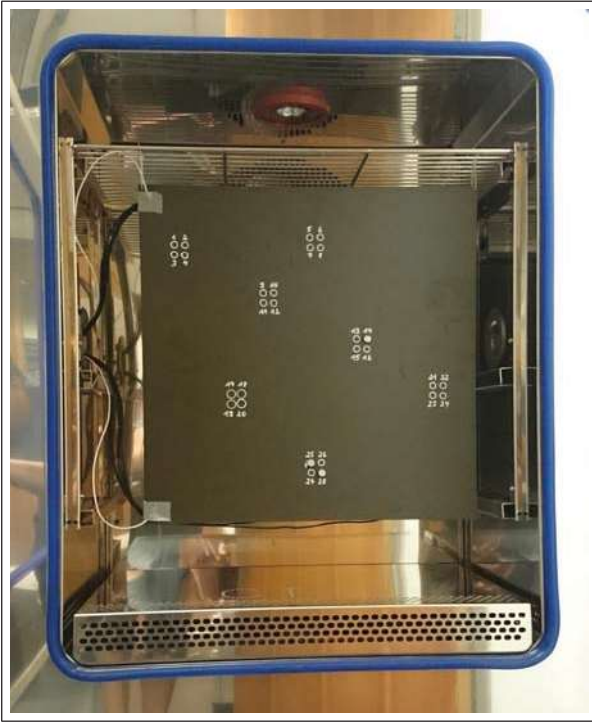
Figure 11. Photo of the ‘SHM plate’ in the climate chamber, where the tests were performed at 23°C and 50% RH. Two temperature sensors were installed on the top left and bottom left to measure the samples surface temperature.

Figure 11 shows the experimental setup with the ‘SHM plate’ placed in a climate chamber at a constant temperature of 23°C and 50% RH (DIN EN ISO 291). On top and at the bottom of the structure Pt-100 temperature sensors were attached to the plates’ surface to assess potential temperature gradients. The temperature sensors

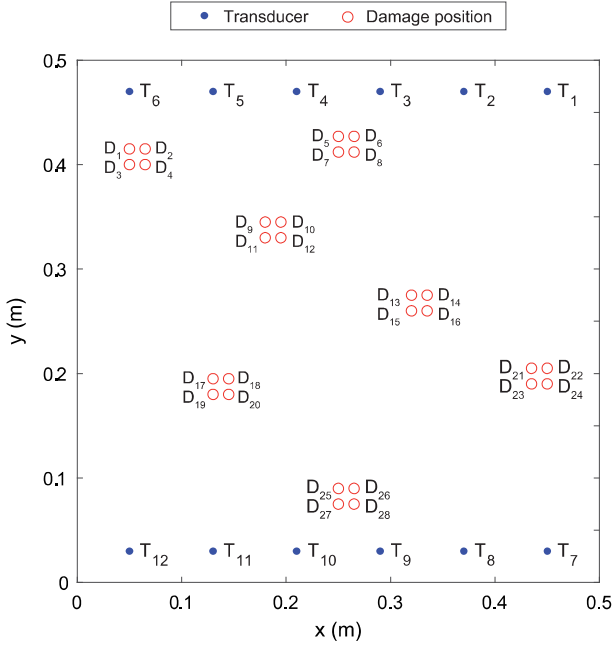
Figure 12. Geometry of the transducer positions T_1 - T_{12} and the defect locations D_1 - D_{28} during the SHM measurements.

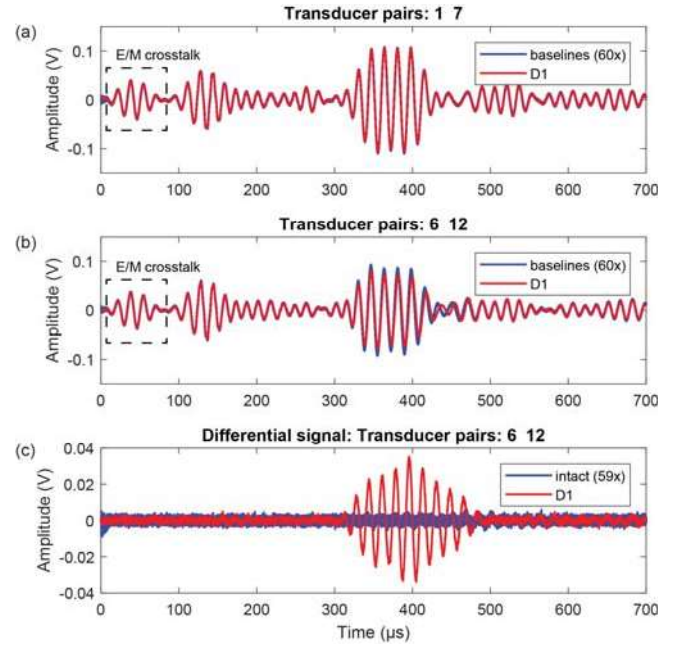
Figure 13. (a,b) 60 Guided wave measurements at 60 kHz from the intact structure (marked in blue) and one guided wave measurement from the damaged structure (marked in red) for two different transducer pairs. (c) Differential signal after baseline subtraction. While the differential signals from the intact structure are measurement noise only, a distinct waveform can be observed in the differential signal due to wave scattering at the defect corresponding to damage case D_1 . All signals were high-pass filtered using a Butterworth filter with a filter order of $n_F=3$ and a cut-off frequency of 20 kHz.

Figure 13 depicts exemplary guided wave measurements at 60 kHz for the transducer pairs $T_1 - T_7$ and $T_6 - T_{12}$. Please note that the geometry of the transducer pairs is symmetric for this case with respect to the boundary of the plate, cf. Figure 12. This leads to similar time-domain signals from both transducer pairs. The signals marked in blue correspond to 60 unique baseline measurements from the undamaged structure including datasets from phases 1, 3 and 5. The signal marked in red corresponds to a measurement where the model defect was placed at damage position D_1 (in the path of transducer pairs $T_6 - T_{12}$). It is interesting to see from the differential representation shown at the bottom of Figure 13 that the measured signals for the intact structure is almost pure measurement noise while a distinct waveform can be observed in the differential signal of the damaged structure. This waveform corresponds to guided wave scattering at the defect, mainly based on the

interaction of the fundamental antisymmetric wave mode with the surface damage. This leads to changes in the measured signals with respect to the baseline signals that can be analyzed for damage assessment.

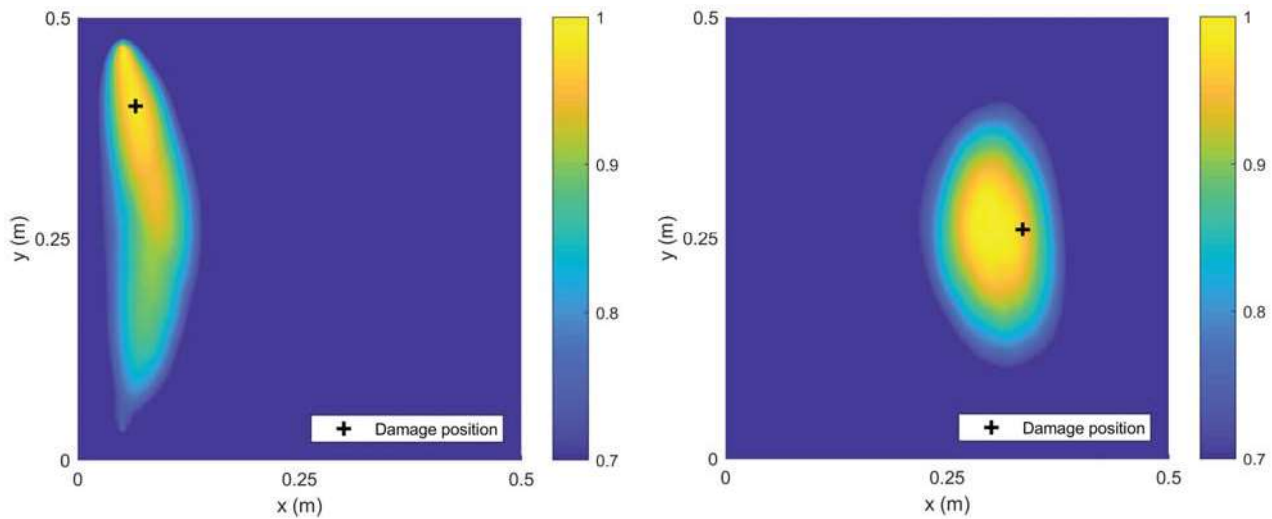
Figure 14. Guided wave tomographic image reconstruction at 40 kHz for damage D_4 (left) and damage D_{16} (right). The scaling parameter of the RAPID-algorithm was defined here as $\beta = 1.1$.

The reconstruction algorithm for probabilistic inspection of damage (RAPID), described in Hay et al. (2006), is well known as a damage localization technique in composite materials. This method was used here to demonstrate the localization capability of guided waves in the proposed CFRP plate. Figure 14 shows two exemplary image reconstruction results based on 40 kHz measurements. It is shown that damage D_4 and D_{16} were localized in both cases. In the analysis only those datasets were included that have transducer pairs on opposite sides (top and bottom), i.e. where the damage is in the direct path of an actuator and its corresponding sensor.
