Imaging Procedures After Bone-Anchored Hearing Aid Implantation

Susan Arndt, MD; Jan Kromeier, MD; Ansgar Berlis, MD; Wolfgang Maier, MD; Roland Laszig, MD; Antje Aschendorff, MD

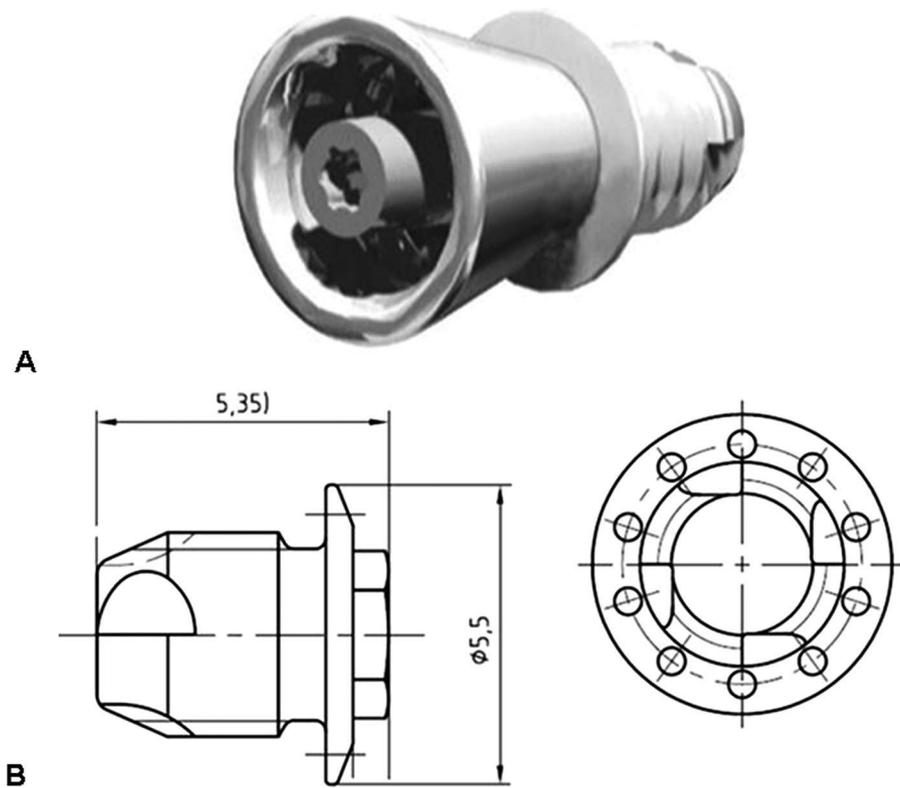
Fig. 1. (A) Four millimeter titanium-based countersunk head screw with premounted abutment. (B) Engineering detail drawing of 4 mm flange fixture (Cochlear GmbH, Germany).

A formalin-fixed cadaver head was implanted with a fixture, 4 mm long and titanium based, self-tapping, and pre-mounted (Cochlear GmbH, Hannover, Germany). Screw dimensions, together with the abutment, are 5.35 mm in length and 5.5 mm in diameter at the top of the abutment (Fig. 1). The screw was implanted obliquely to determine the best method for detecting the angle. Furthermore, we did not perform a disposal well for determining the distance of the abutment from the temporal bone.

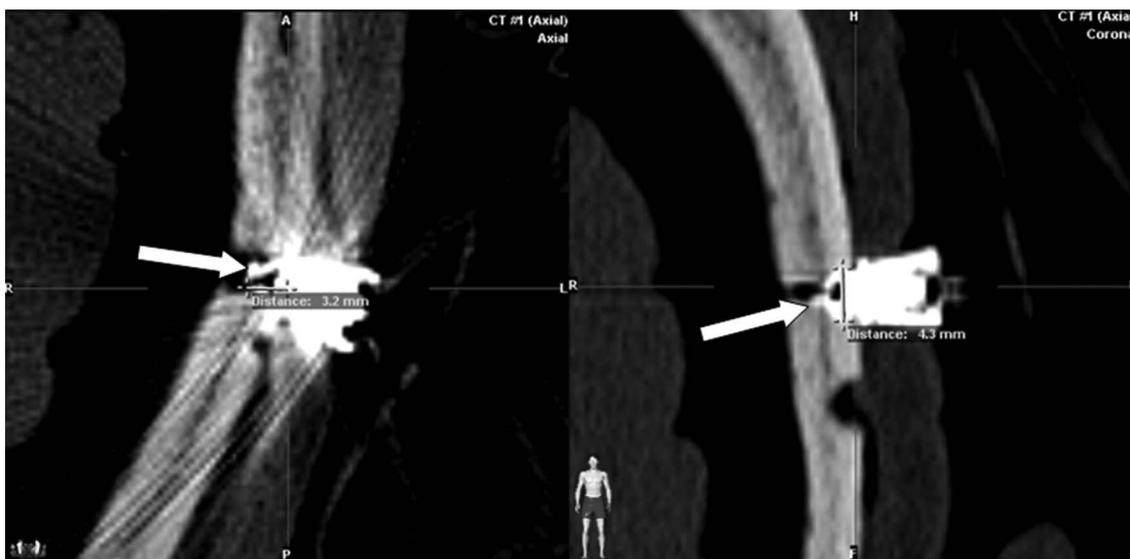
Fig. 2. Multislice computed tomography imaging (left, axial; right, coronal) in human temporal bone after screw implantation. Arrows indicate artifacts that do not allow definition of exact end of screw.

partial volume effects. The drill hole, penetrating the entire temporal bone diameter, could also be seen, but the exact length of the screw in the bone was difficult to quantify because of the artifacts (Fig. 2). RT allowed identification of the accurate position of the screw (Fig. 3). The metallic artifacts caused by the implanted screw were negligible. The exact angle between the screw and skull surface could be identified accurately with RT imaging (Fig. 4). Furthermore, RT clearly depicted the

Our results demonstrate that multislice CT scans show only small artifacts but are not useful for differentiating the screw position. The depth of the screw within the bone could not be measured accurately. The artifacts in MRI resemble oblong “black holes” that blot out the underlying image and sometimes distort nearby structures.⁷ The distortion of the image is related to the degree of deflection of the object in a magnetic field caused by its ferromagnetism.⁸ In our study, the screw produced a “black hole” type artifact even larger than the actual drill hole or screw. In addition, the artifacts included the imaging of the dura, so any injury to the dura could not be evaluated sufficiently. We performed the CT and MRI with 1 mm slice thickness and the RT with 0.5 mm slice thickness. According to our results, this difference of 0.5 mm has no influence. It might be possible to reconstruct

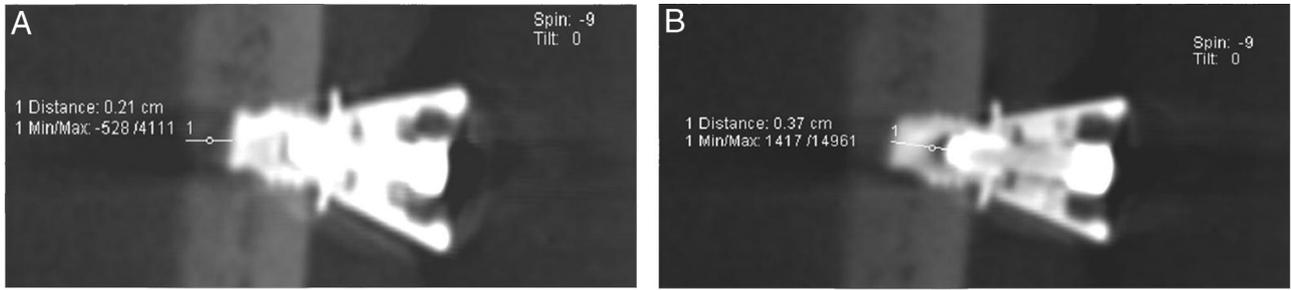
Fig. 3. Rotational tomography shows accurate position of the implanted screw and distance to dura. (A and B) sagittal.

length of the screw in the bone and the distance to the dura (Fig. 3).

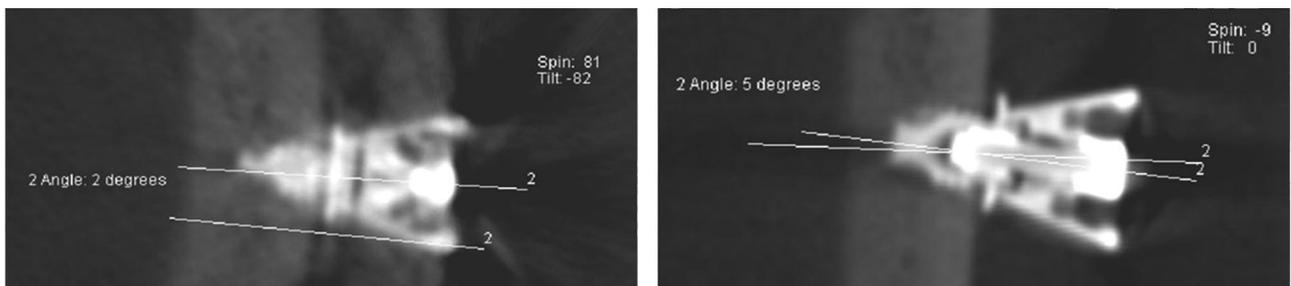
Fig. 4. Angle between screw and skull surface is clearly visible in rotational tomography imaging. (A) axial; (B) sagittal.

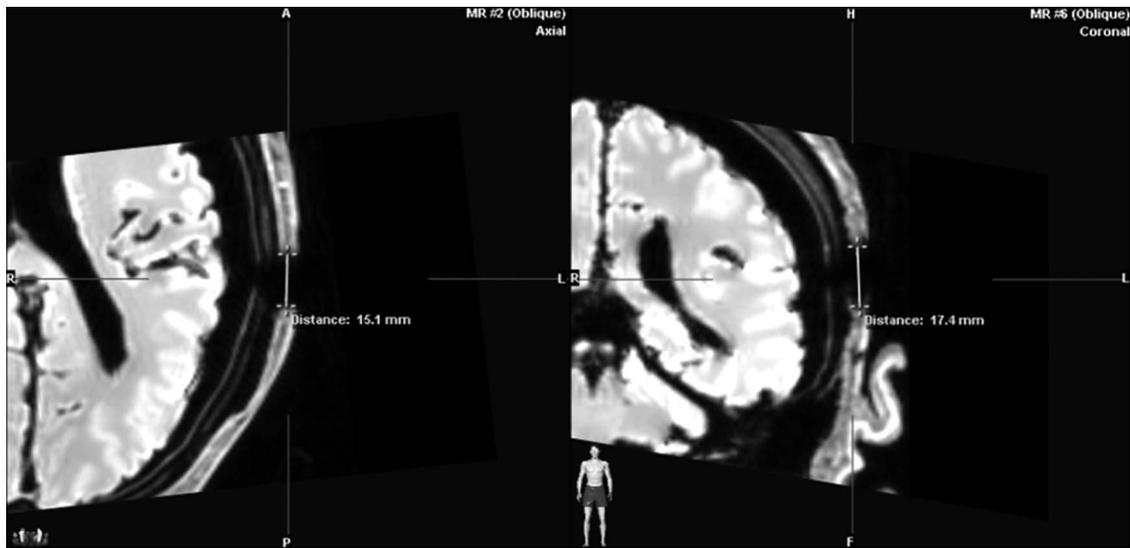
Fig. 5. “Black hole” type artifact in magnetic resonance imaging including the dura (left, axial; right, coronal).

In the MRI scans, the screw was not visible, but the location of the screw hole in the temporal bone could be identified because of the artifact. The artifact was 15.1 to 17.4 mm (Fig. 5), and therefore evaluation of the screw or possible injury to the dura was not available.
